*Report of Building Inspection & Code
Analysis - The Brown Church at 132 Main Street
Conway Village New Hampshire
Prepared for the Board of Trustees
Conway Village Congregational Church*

**Bergeron Technical Services LLC
290 East Side Road, Conway, NH
P.O. Box 241 North Conway, NH 03860**

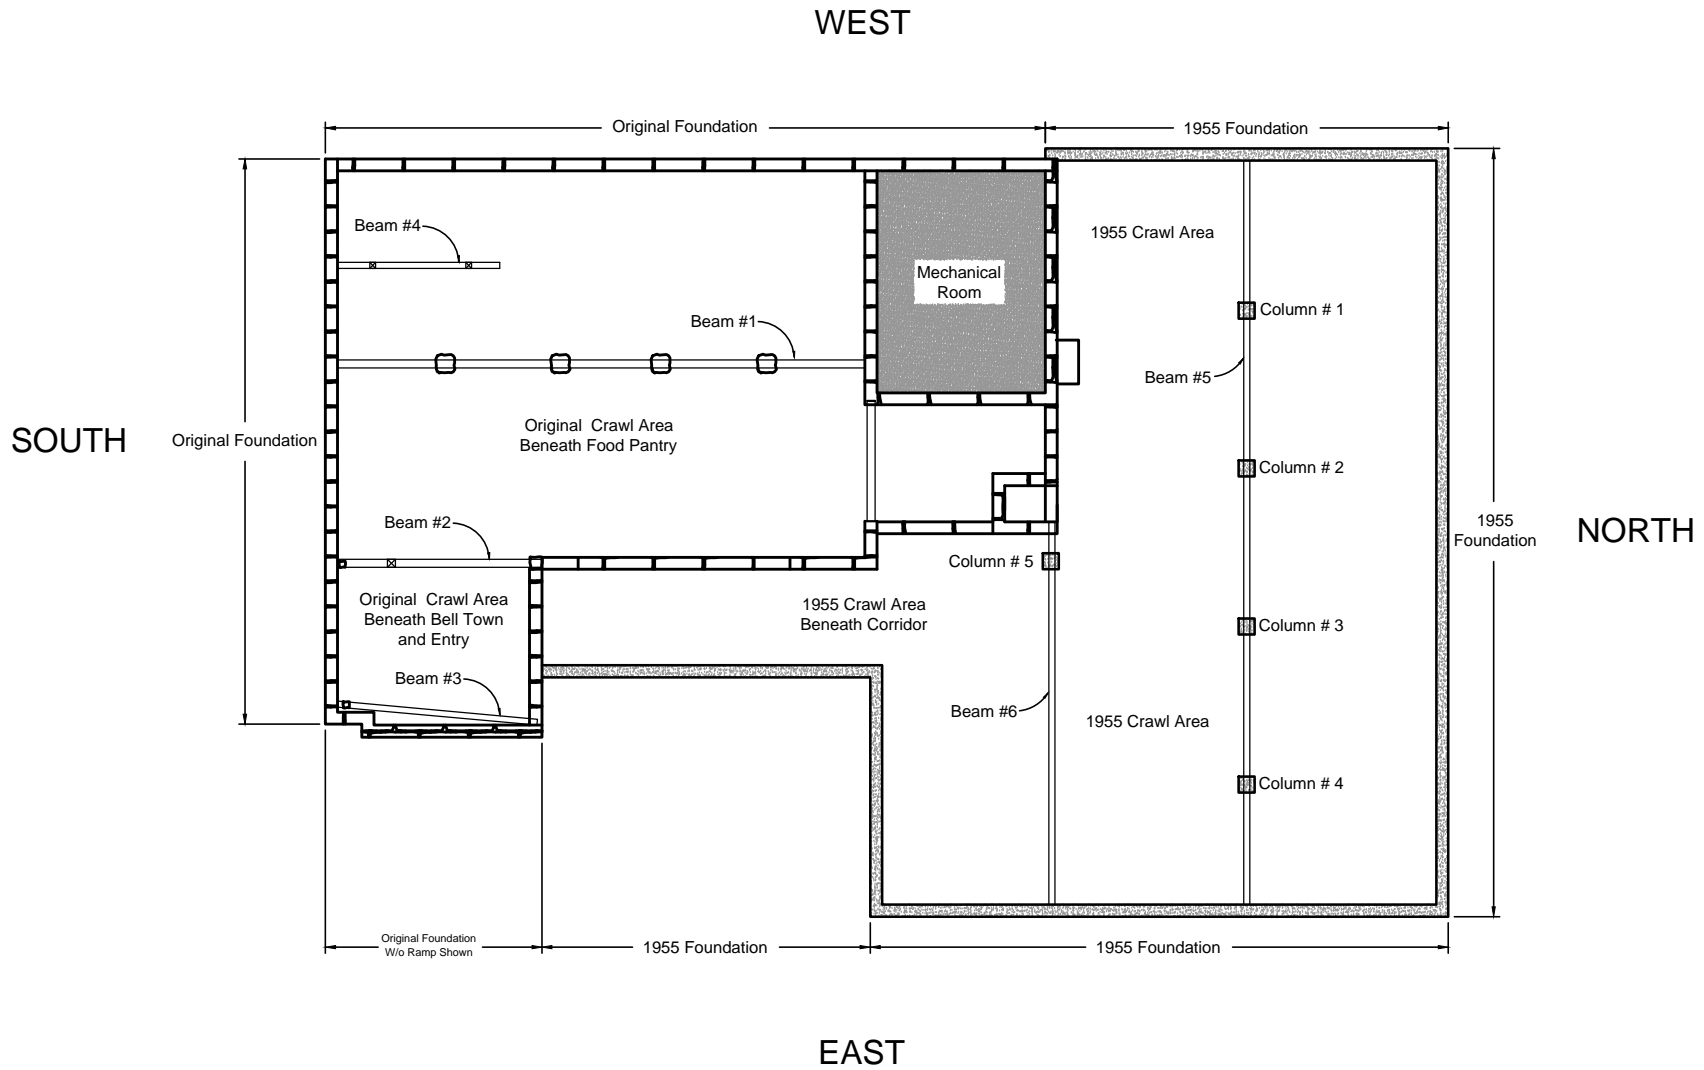
1 Crawl Space Configuration
SCALE: Not to Scale

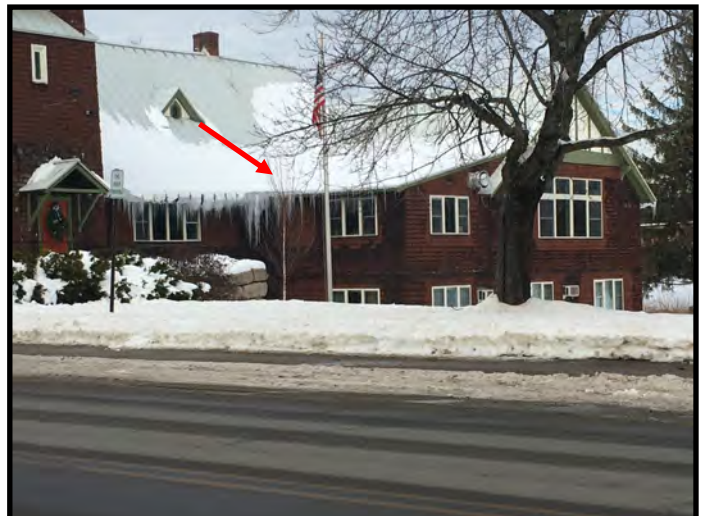
Ice dam and leaking roof valley

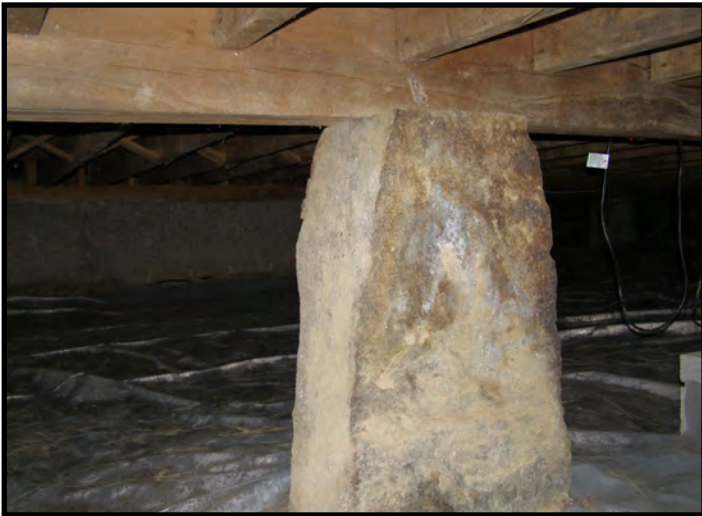
Granite Main Supports Beneath Original Building

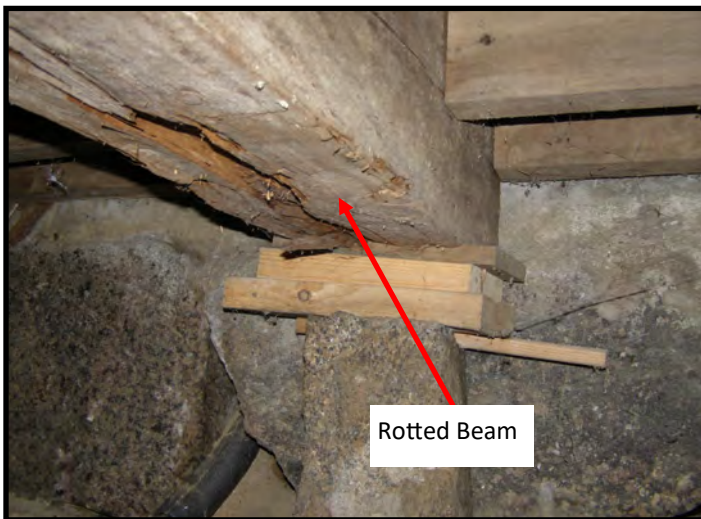
Improved Supports Beneath Original Building.

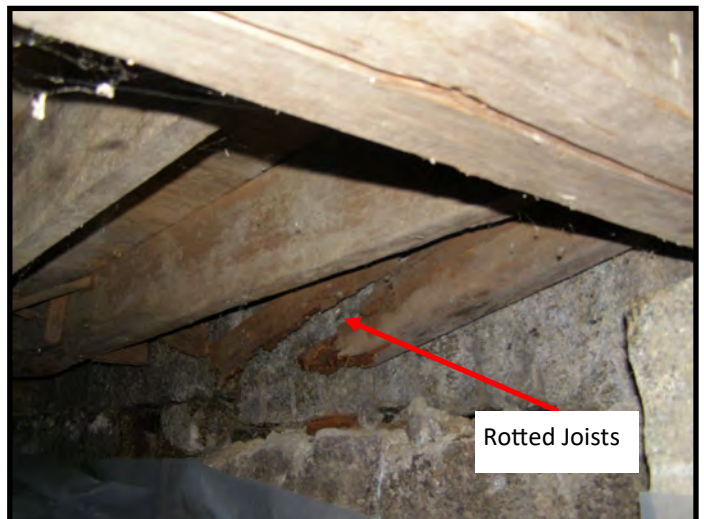
South Foundation Wall - End of Main Beam

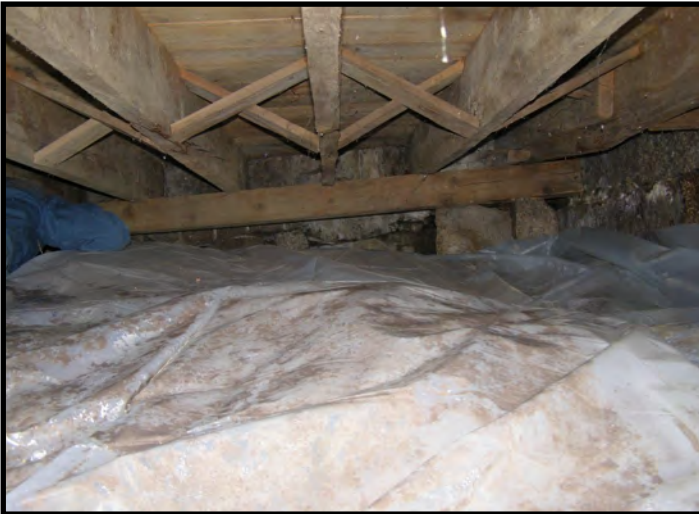
Beneath Main Entry Looking Towards Salyards

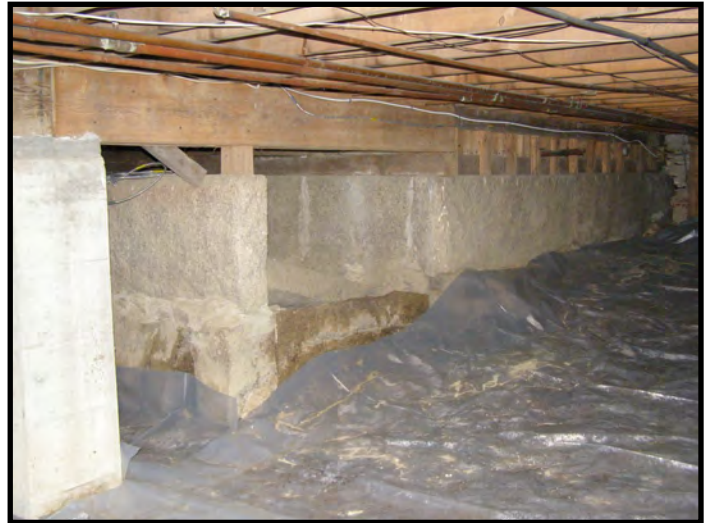
Transition Original to 1955 Foundation In 1955
Crawlspace. Granite Wall is North End of Original Building

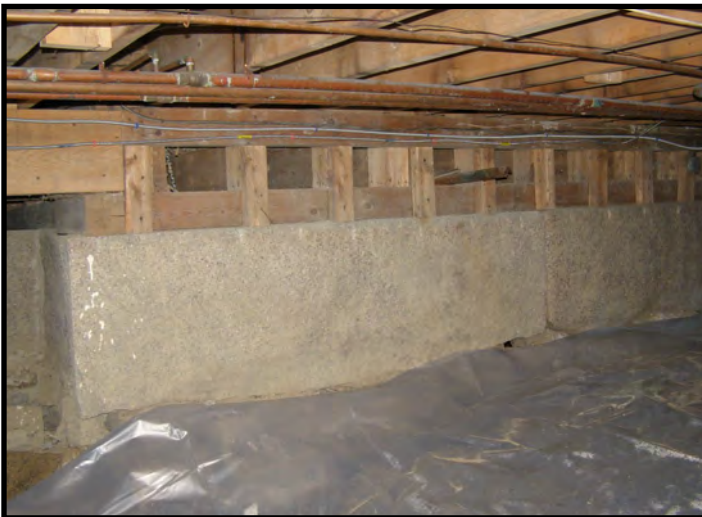
Foundation Beneath Original Building Area—North Side

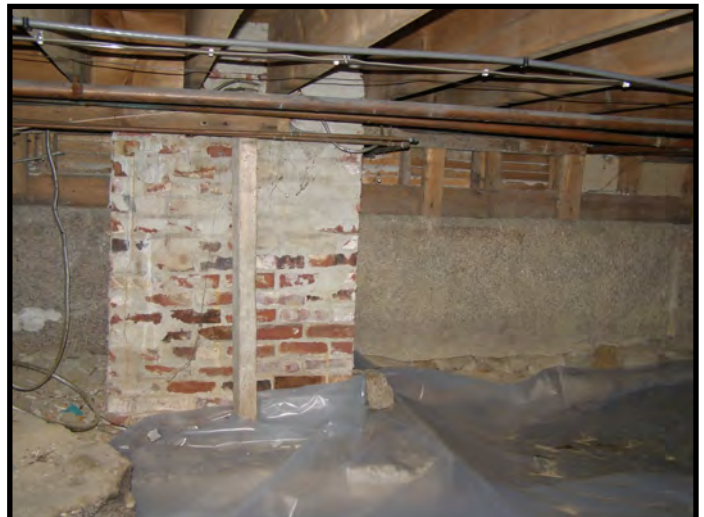
Base of Chimney - 1955 Crawl Area - Looking South

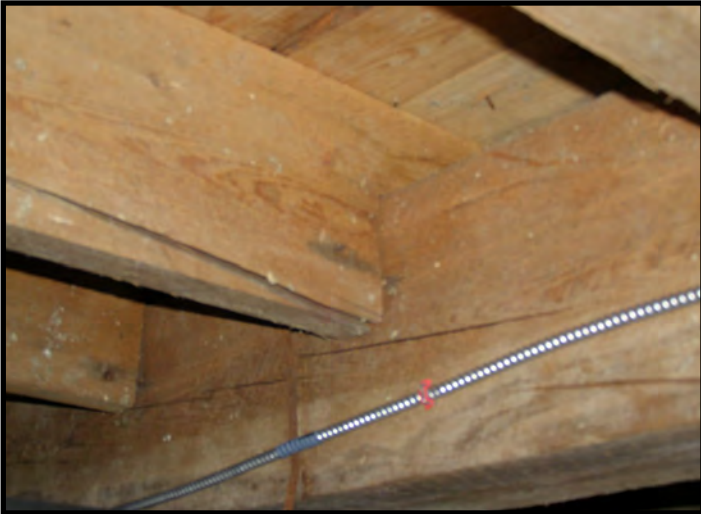
Proper Wiring Method & Improperly Notched Floor Joists

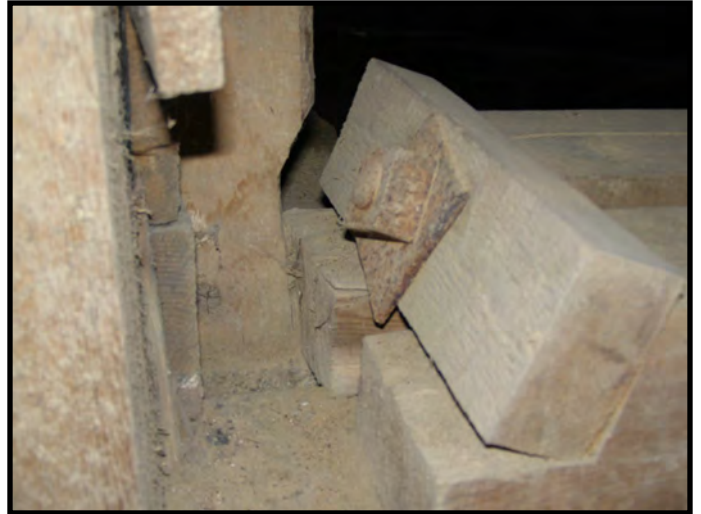
Tension Rod Head Nut/Washer - Tension Rod at Lower Left

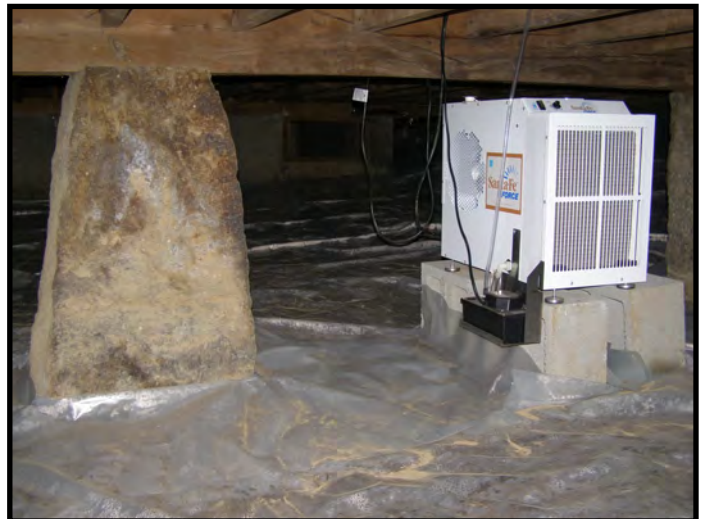
Dehumidifier Beneath Food Pantry - Nicely Done

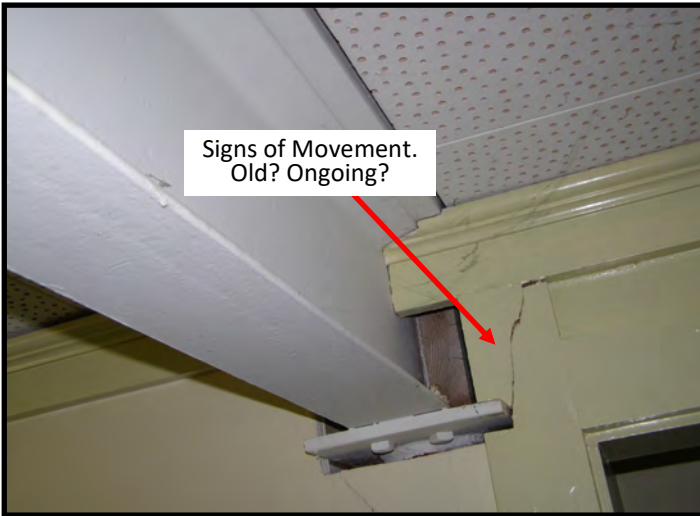
Wide Flange Floor Support Beam - Lower Hallway

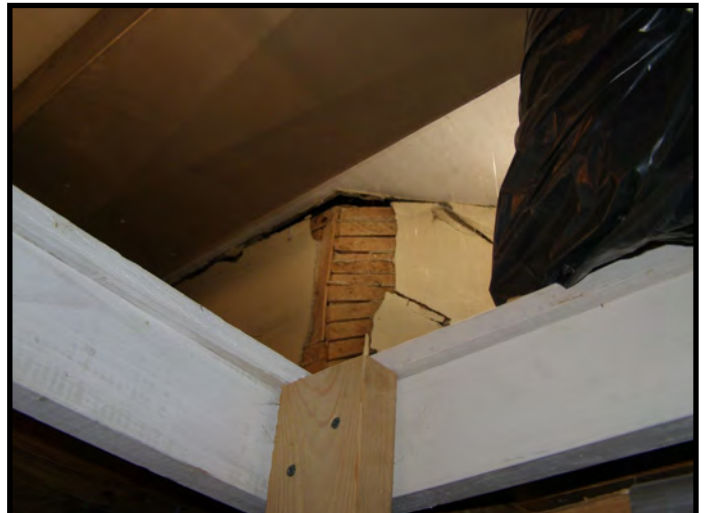
Lower Level South Exterior Wall - Plaster Deterioration as Wall Dropped, Due to Floor Having Dropped Out Beneath the Wall

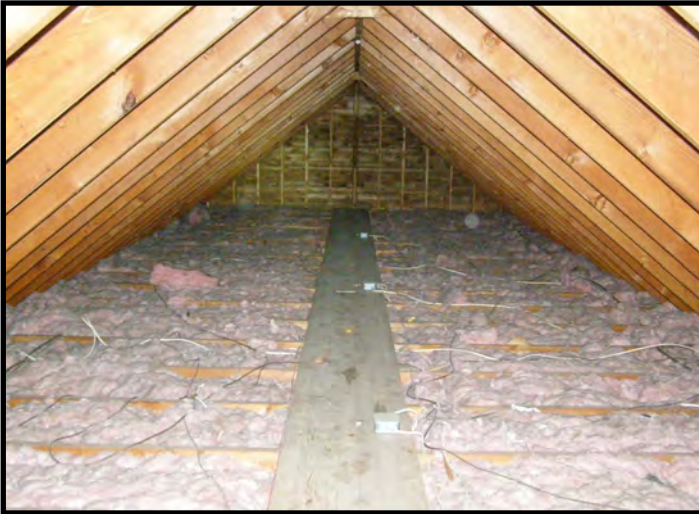
1955 Attic - Looking Towards Salyards

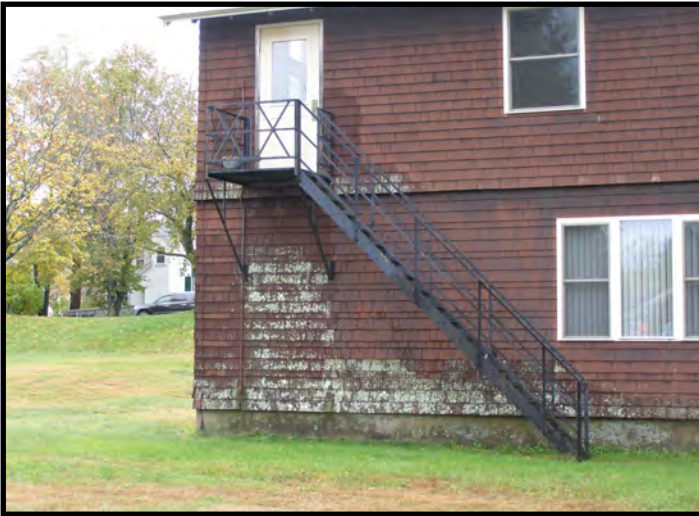
Fire Escape & Deteriorated Siding - Time to Replace Both

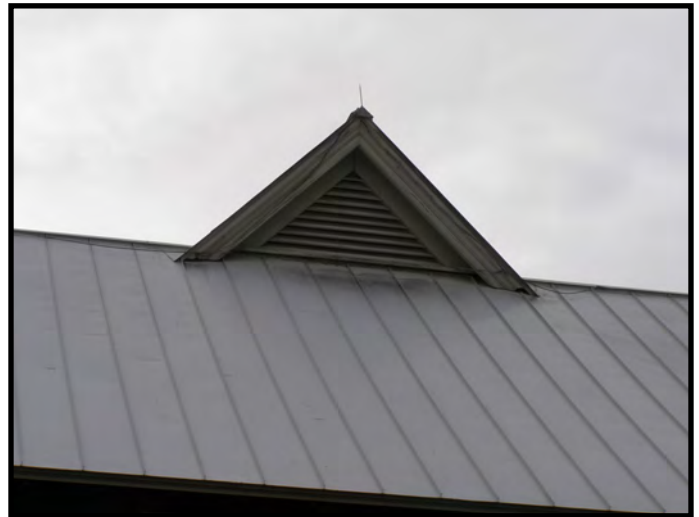
Exterior View - Operable Gable End Louver

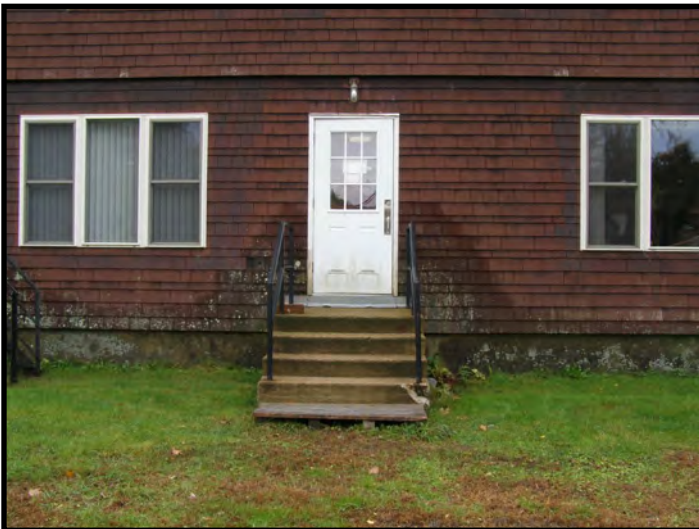
Lower Hallway Exit Towards the North - Note Siding Condition

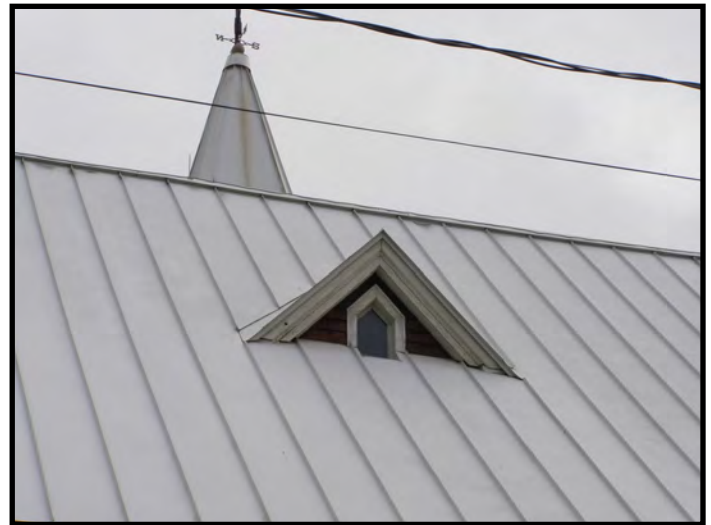
Small Dormer at Sanctuary - Completely Salvageable

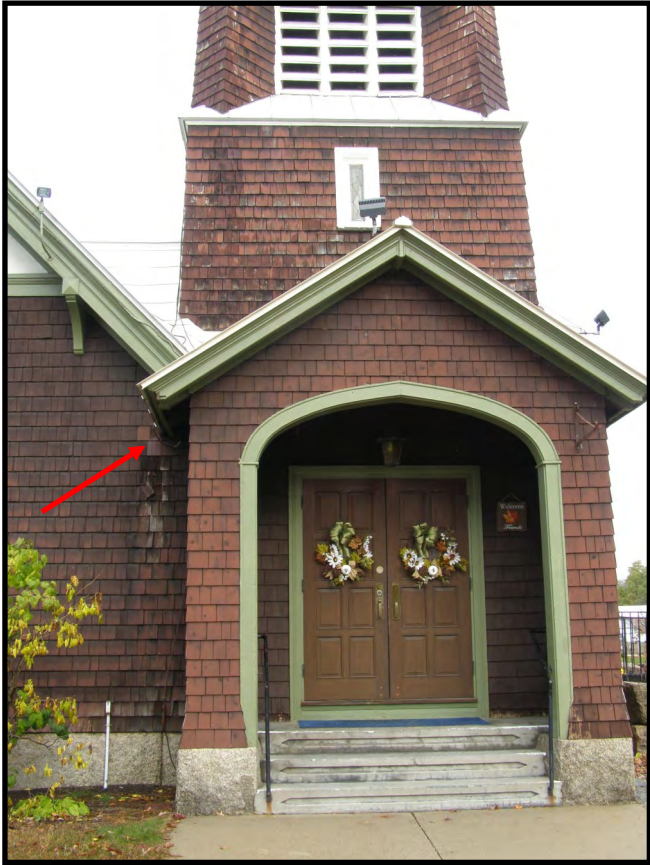
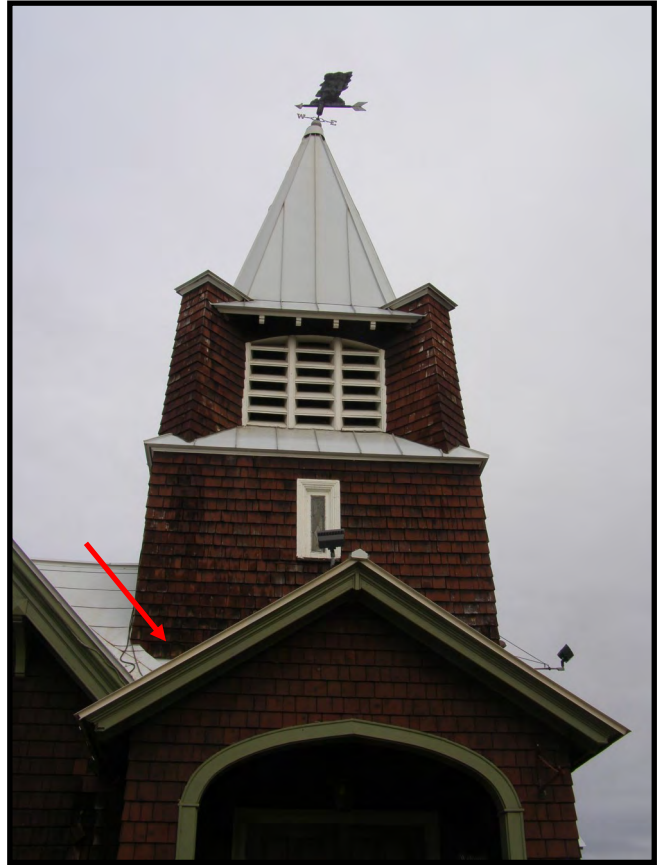
The Wonderfully Attractive Main & Side Entries. Arrows Indicate Rot Deterioration - Lots of It!

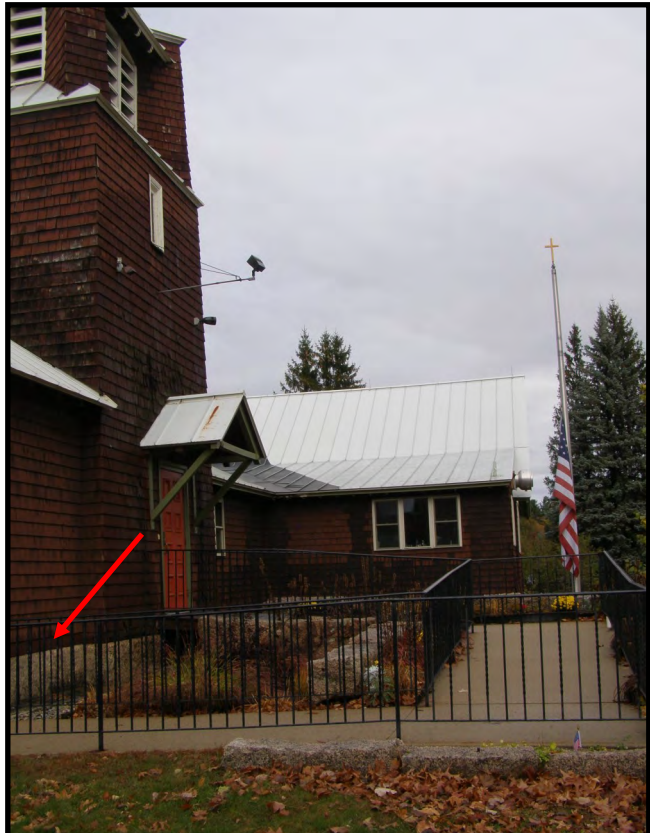
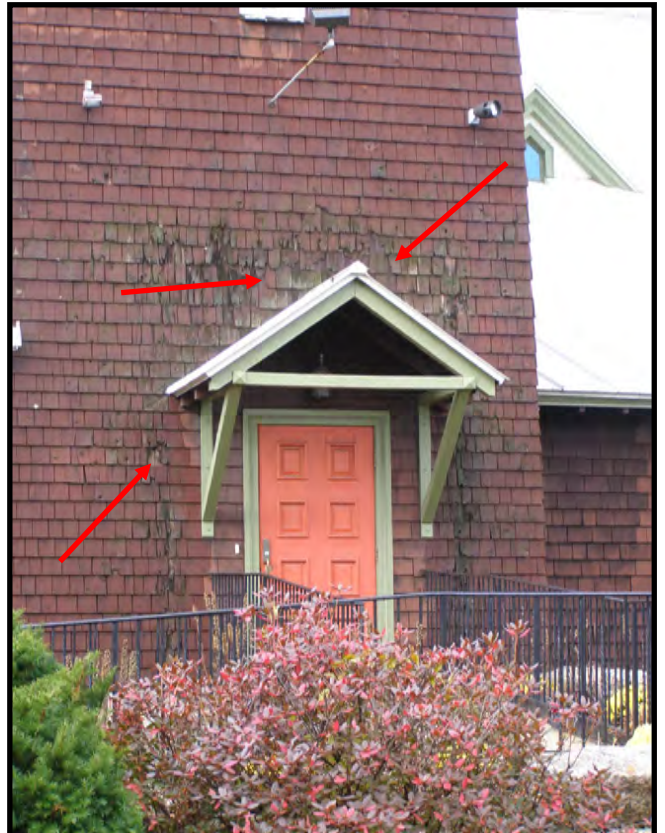
The Brown Church
132 Main Street
Conway, NH

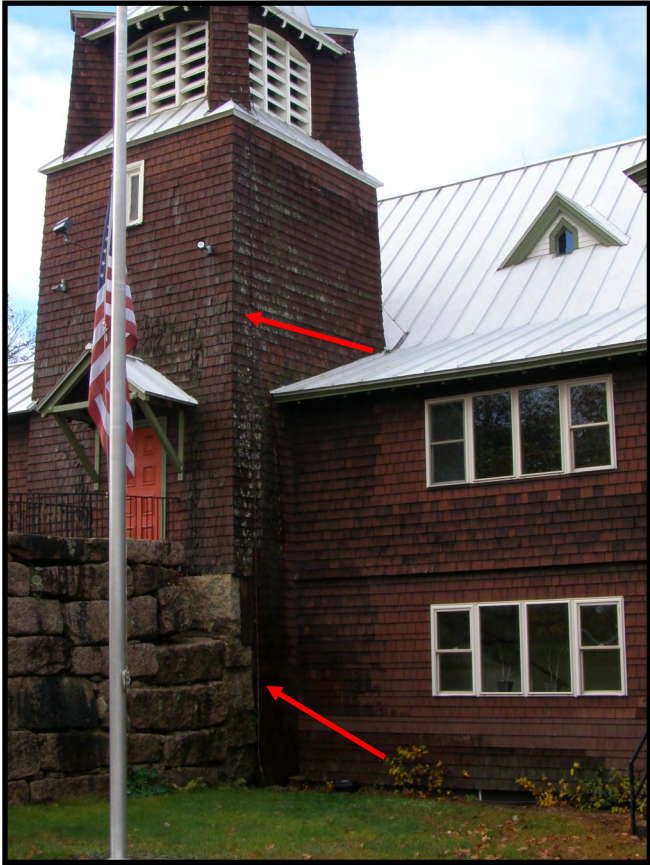
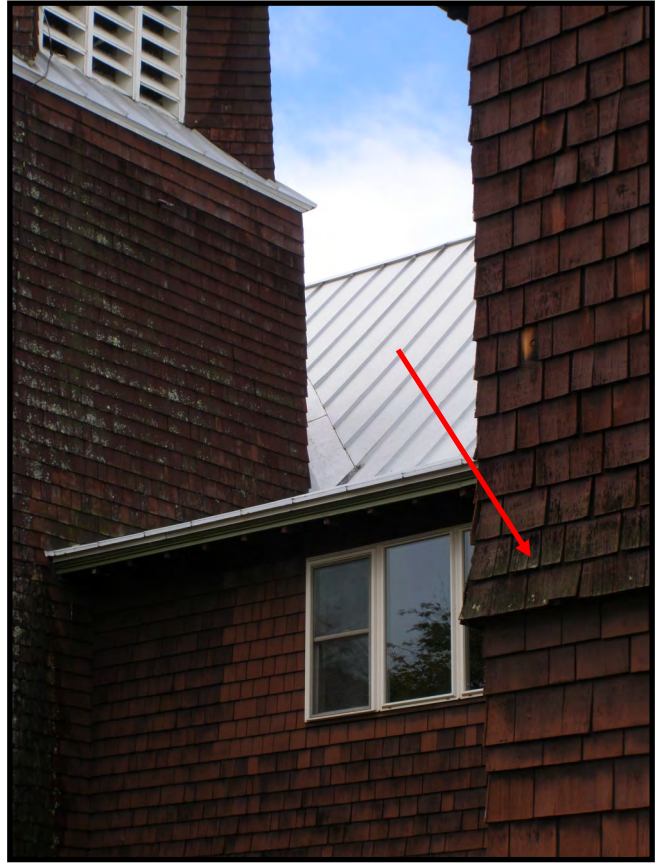
Arrows Indicate Rot Deterioration - Depth of Deterioration Is Going to Vary from Siding Only to Into the Framing

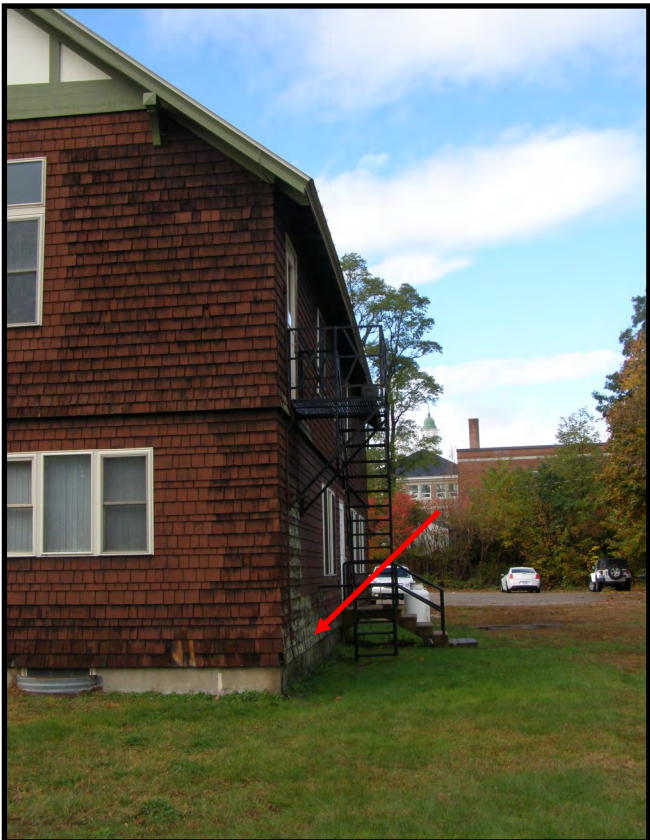
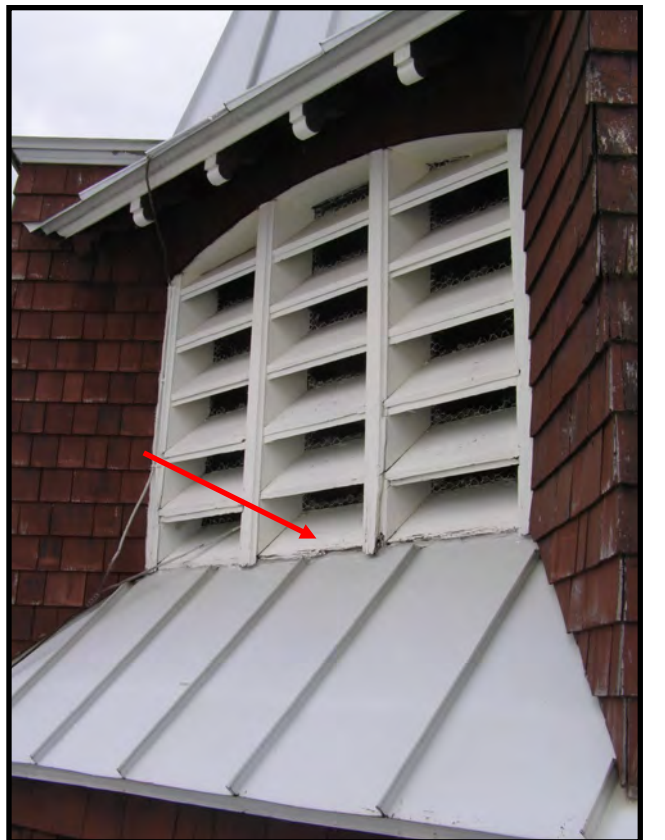
The Brown Church
132 Main Street
Conway, NH

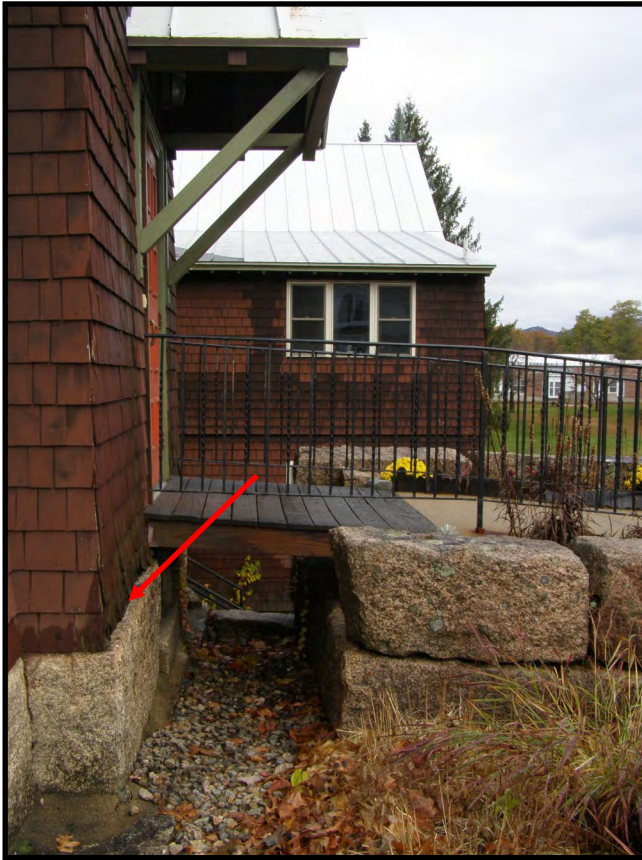
A Bad Original Building Detail - Rot Maker!

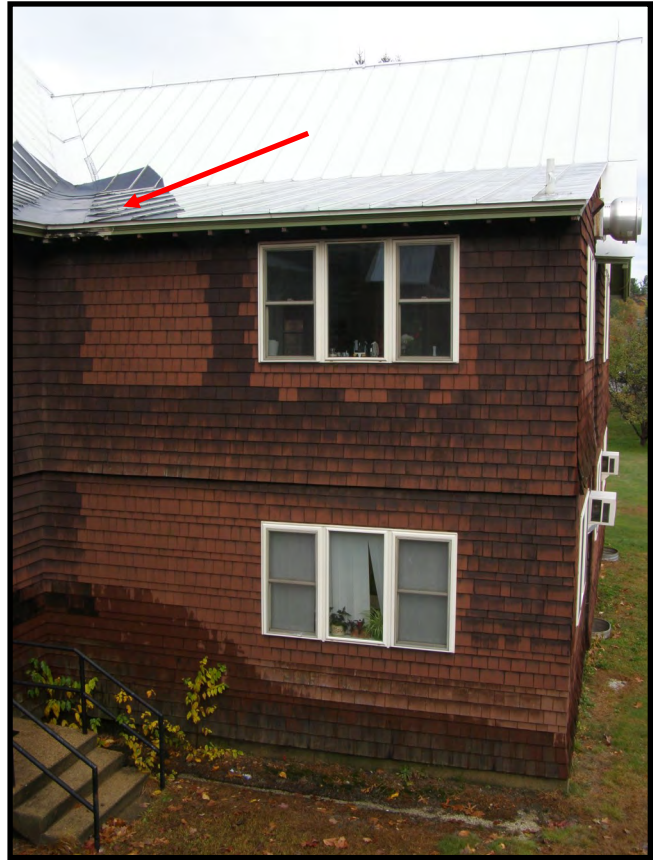
An Example of How to NOT Do a Roof Valley

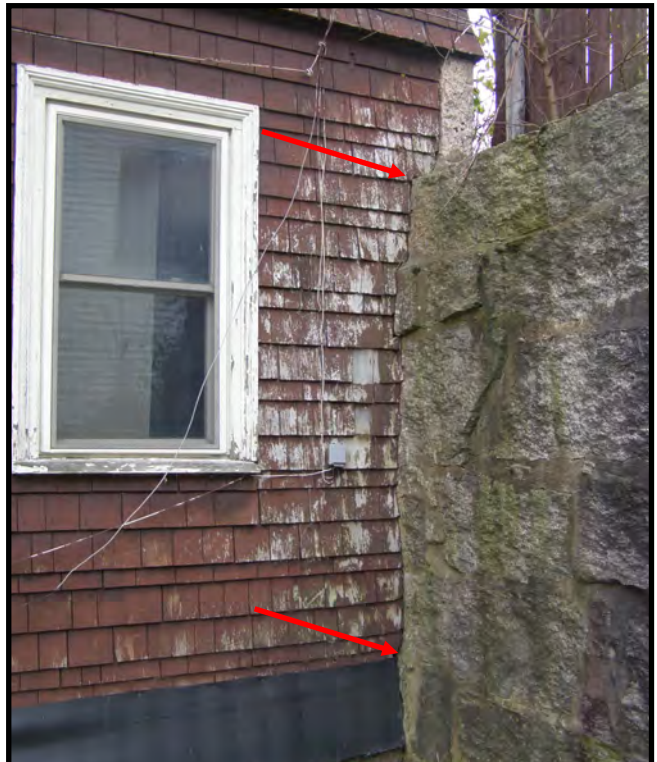
Arrows Indicates Rot - Lower Arrow Indicates Opening Into the Building. South West Corner of Building

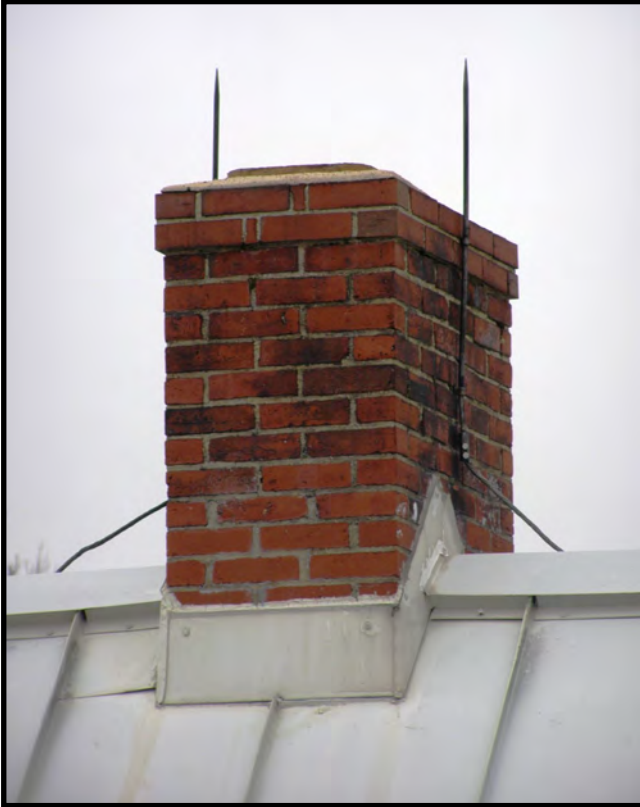
The Chimney - Let's Make It Go Away

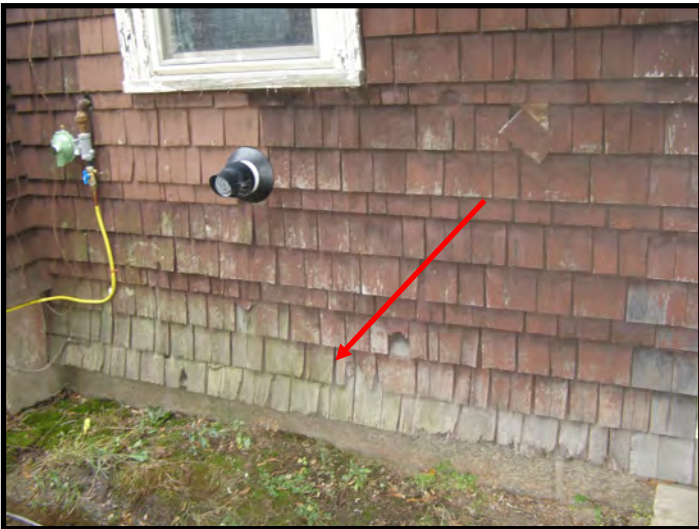
Red Arrow Indicates More Water/Rot Deteriorated Siding

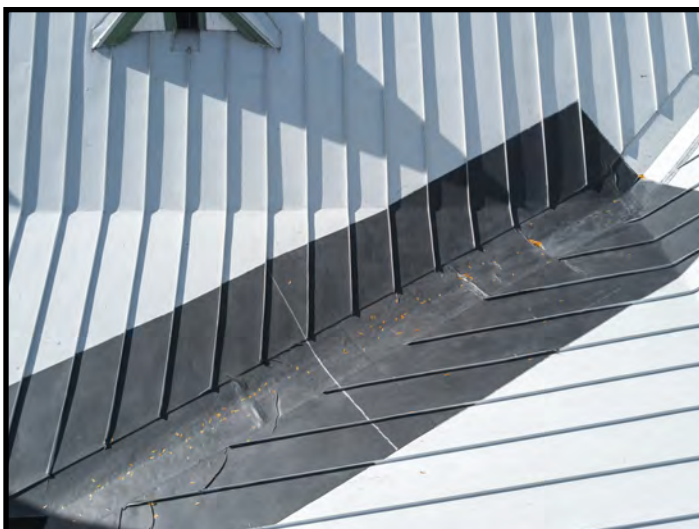
The Roof Valley "Repair" That Needs a Real Repair

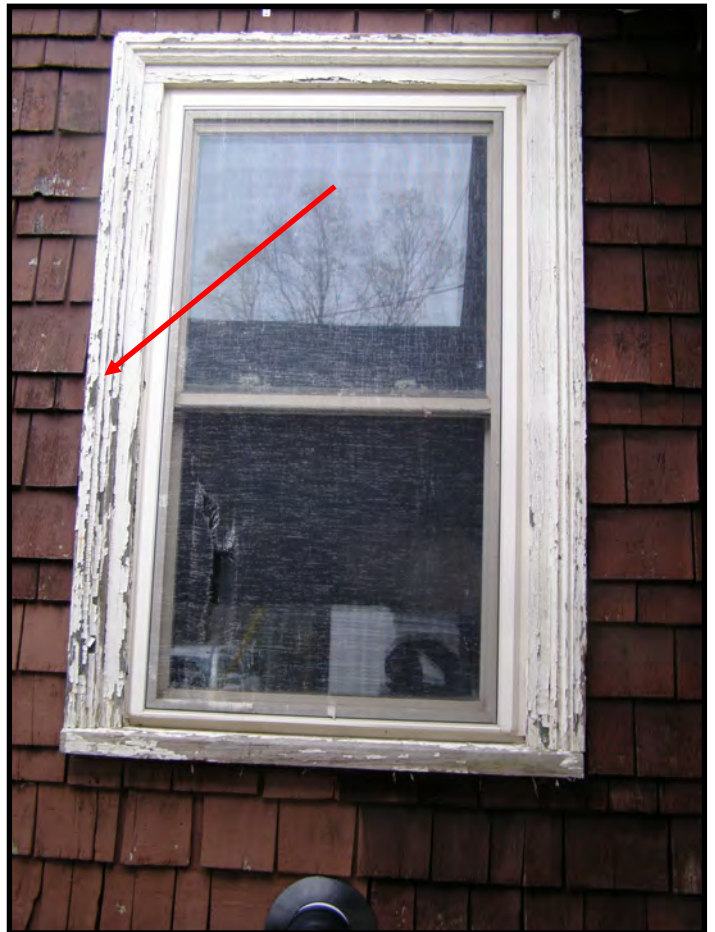
Replacement Window in Original Frame. Arrow Indicates Flaking Lead Based Paint

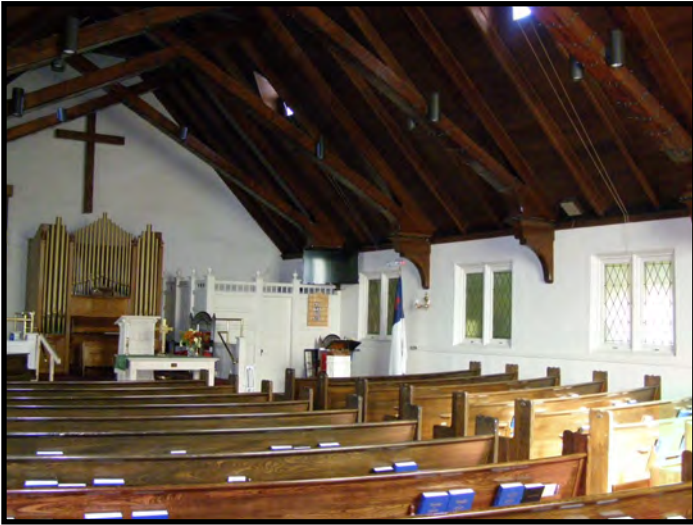
An Architecturally Wonderful and
MUST BE PRESERVED Sanctuary

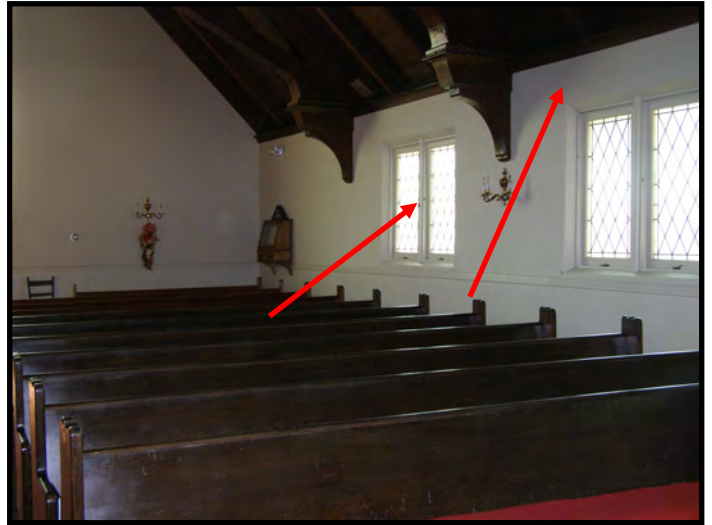
West Sanctuary Wall. Arrows Indicate Where Wall Is Tipped
Outward and Stain-Glass Windows That Need Preservation

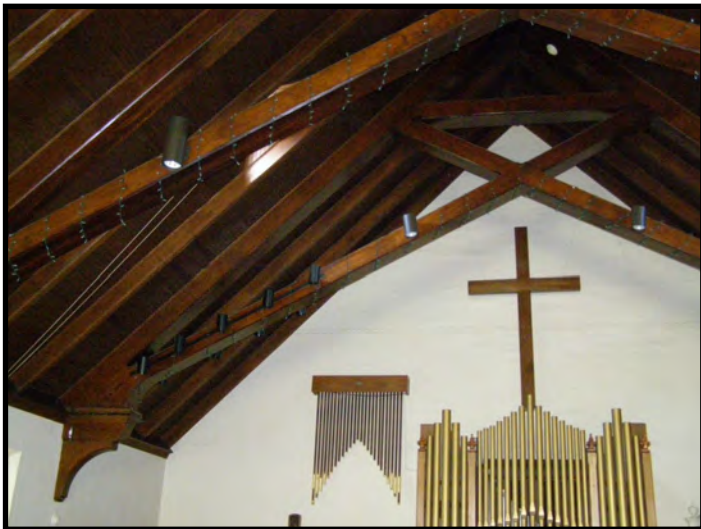
Beautiful Scissors Trusses and Organ

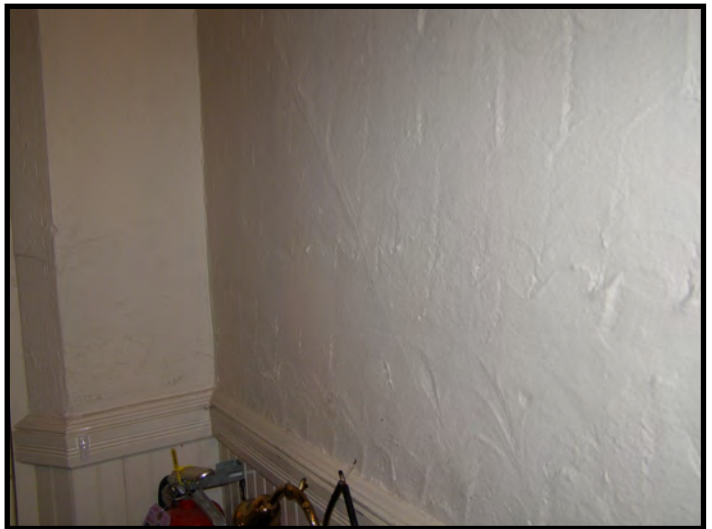
Deteriorating Sanctuary Plaster Is a Serious Concern

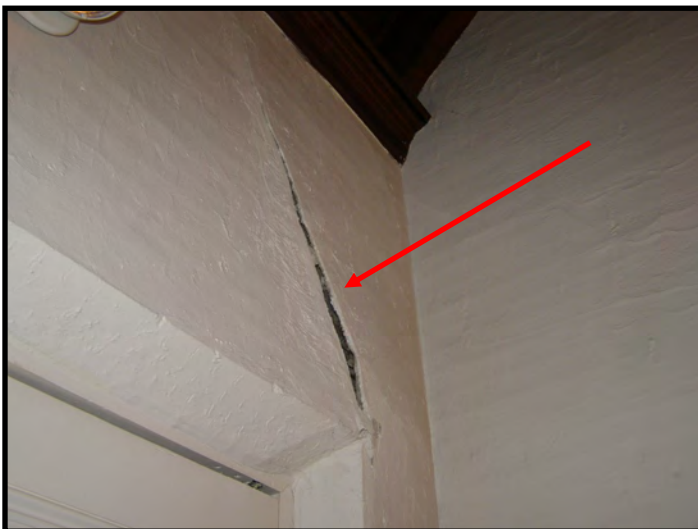
Deteriorating Sanctuary Plaster Is a Serious Concern

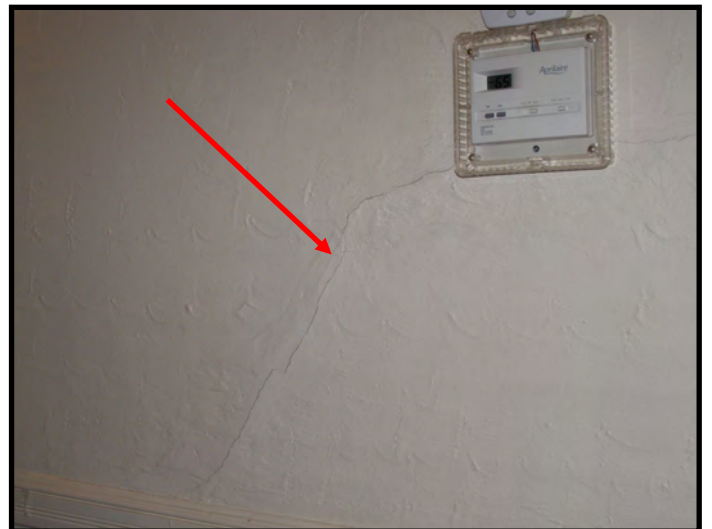
Deteriorating Sanctuary Plaster Is a Serious Concern

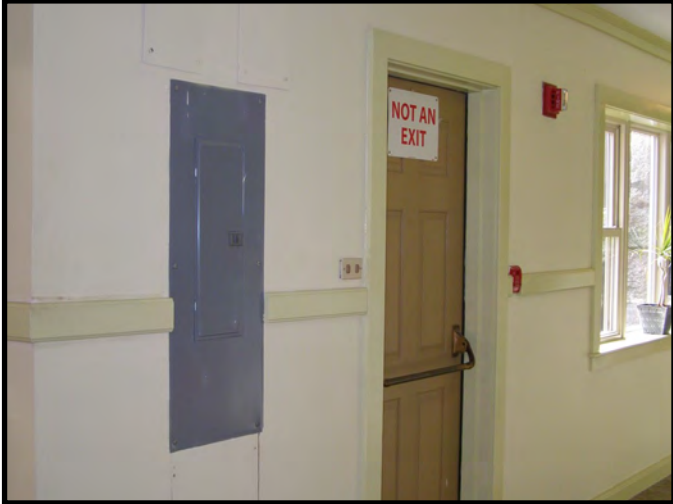
Electrical Panel - It's Salvageable or Replaceable. Planning Will Decide

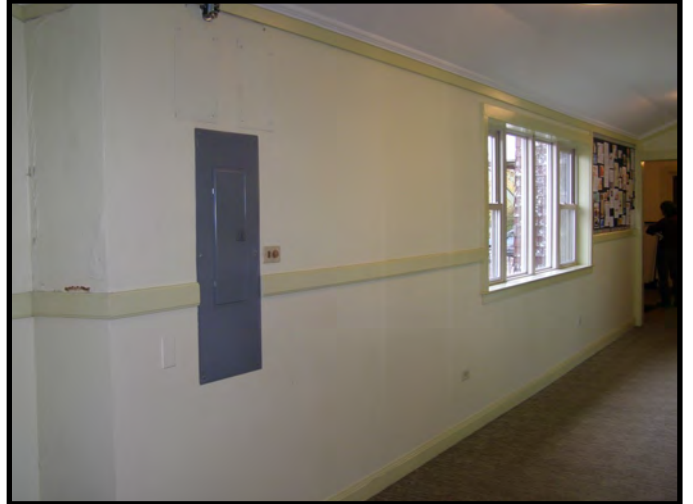
Electrical Panel - It's Salvageable or Replaceable. Planning Will Decide

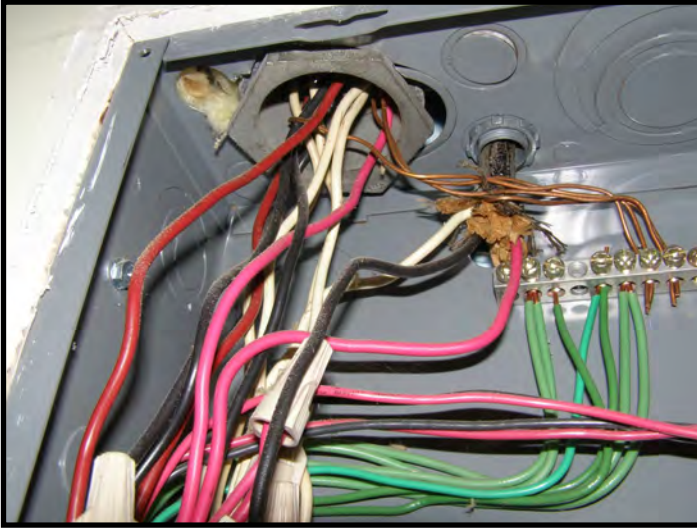
Sure, Improvements Can be Made

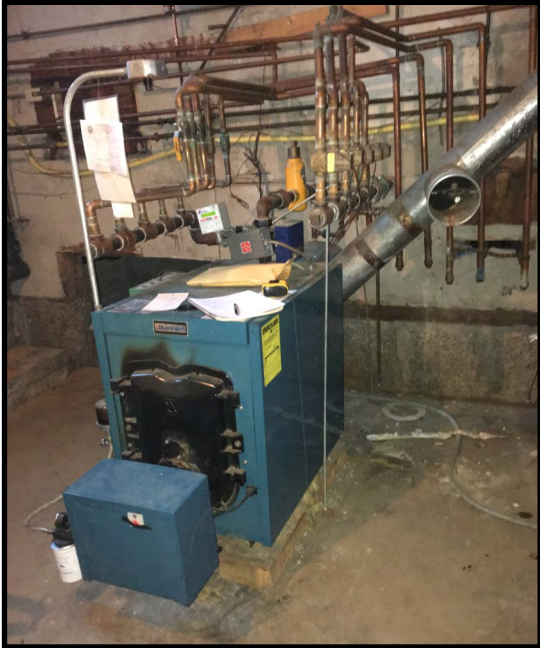
2007 Boiler - Needs Maintenance or... Replace?

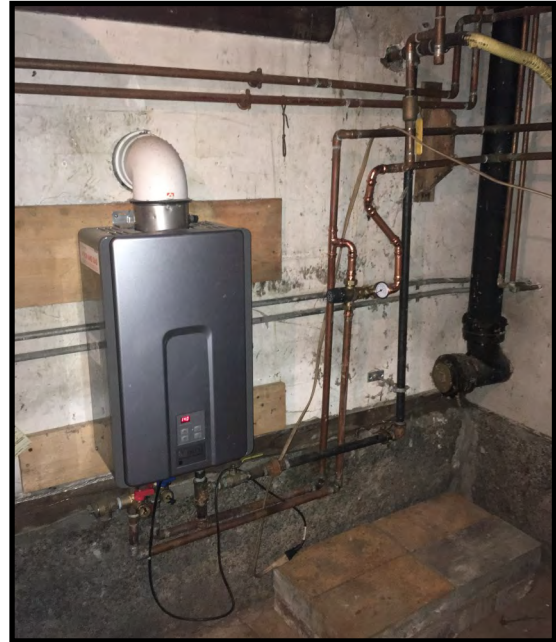
A Good Water Heater - Improve Installation

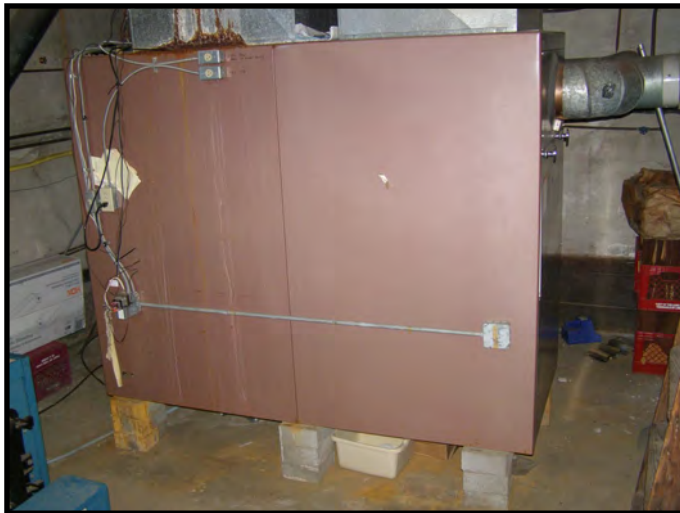
Undetermined Vintage Furnace - Needs Maintenance or... Replace? Let's Talk Replace.

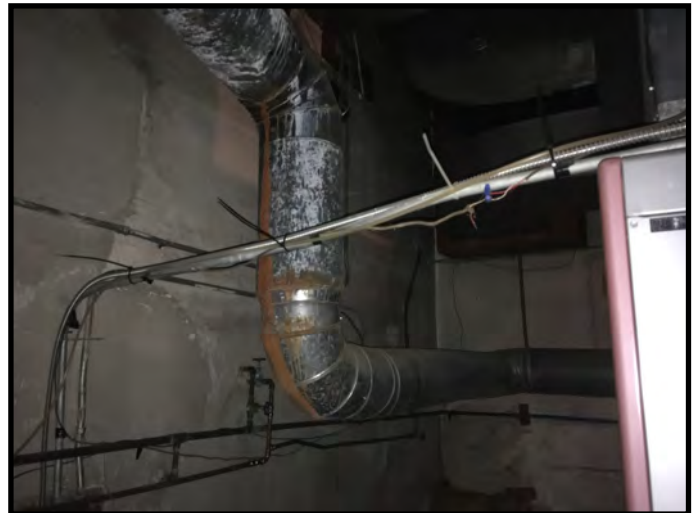
Furnace Vent Connector - Must Be Corrected

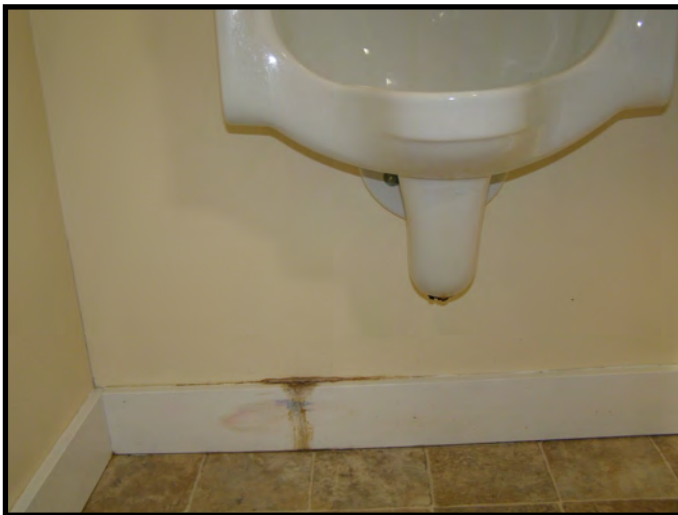
Mens Room - Active Leak?

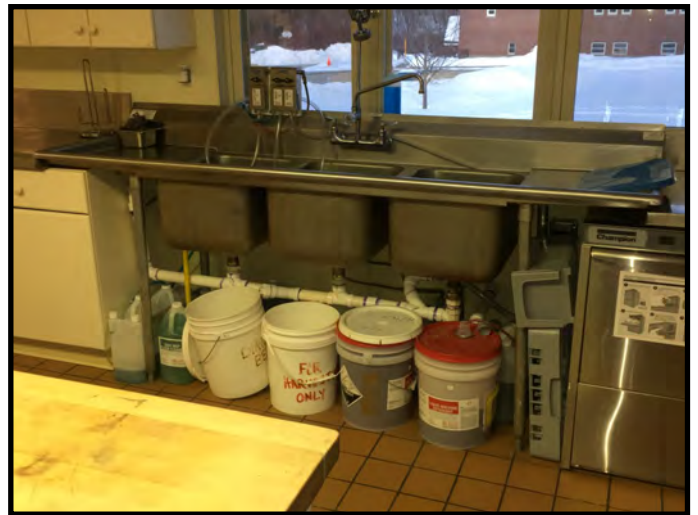
Kitchen - Some Plumbing Improvements Will Be Beneficial
